New York State Department of Transportation

Yellow Flag NB2228W018

BIN: 1065318

Yellow Flag No. NB2228W018

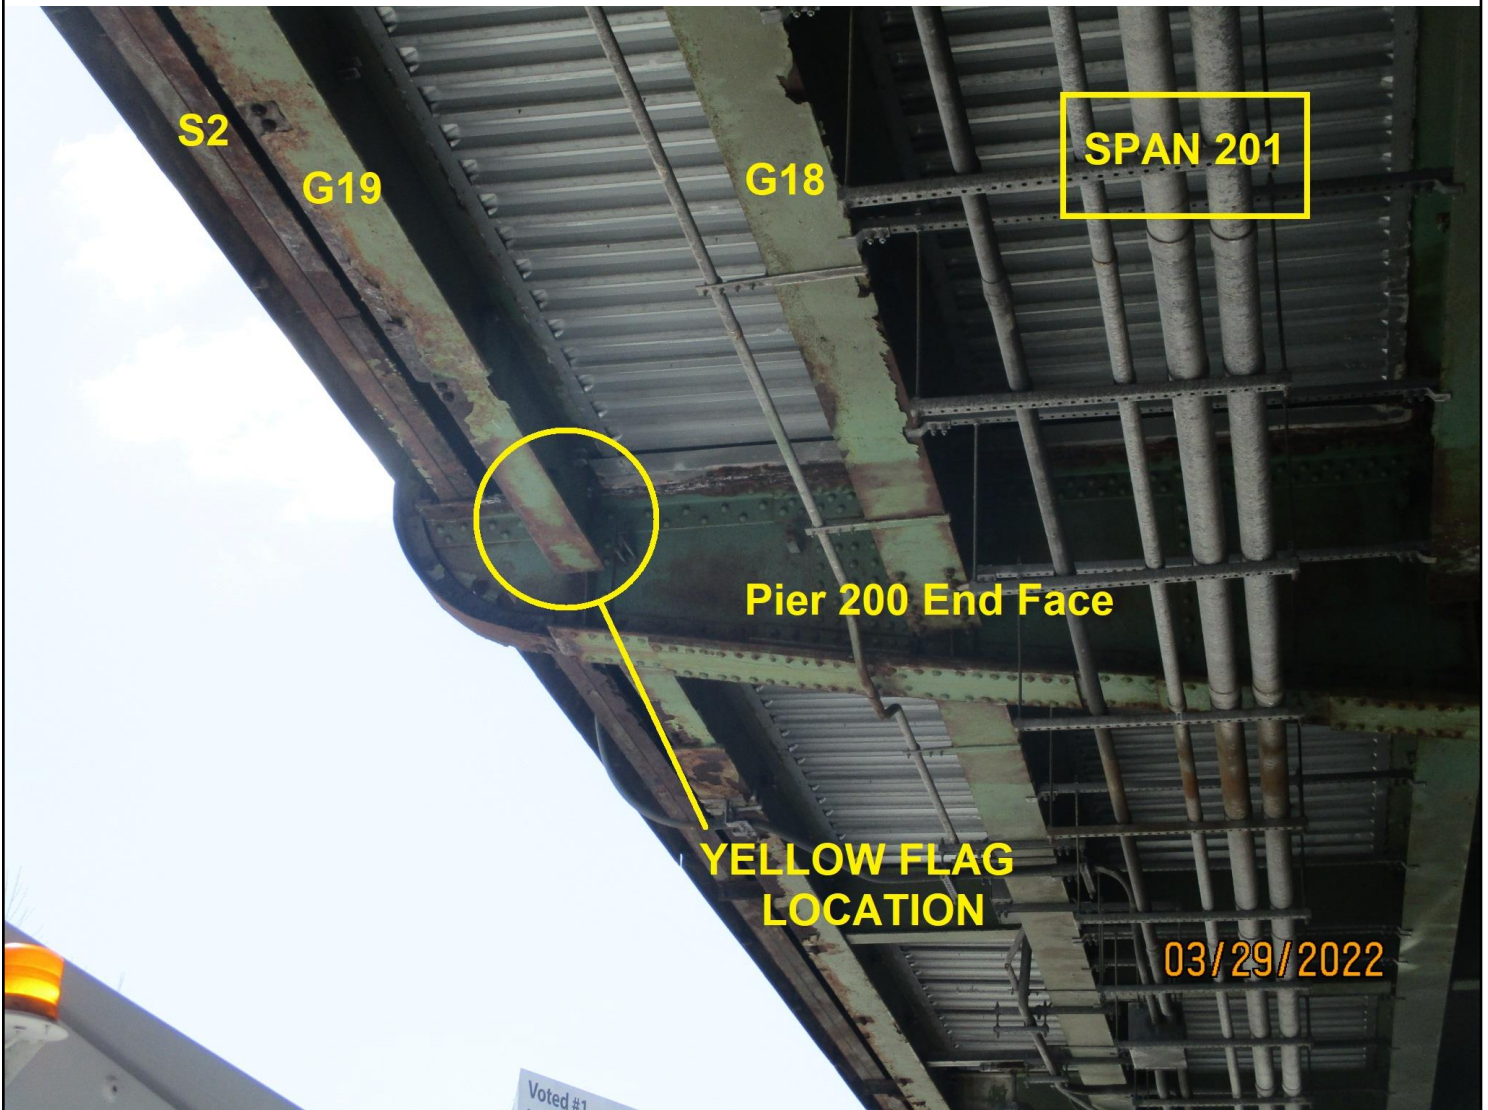
Photo Number: 1

Description: The right clip/connection angle of Girder G19 connection to the end face of the pier cap at Pier 200 exhibits a 3" long vertical crack x 3/4" wide at the lower fillet section (deterioration induced cracking). The remaining section of the clip/connection angle has heavy corrosion with up to 3/16" section loss.

Attachment Description: Span 201, Girder G19 at Pier 200. General view of the flagged location. Looking Begin.

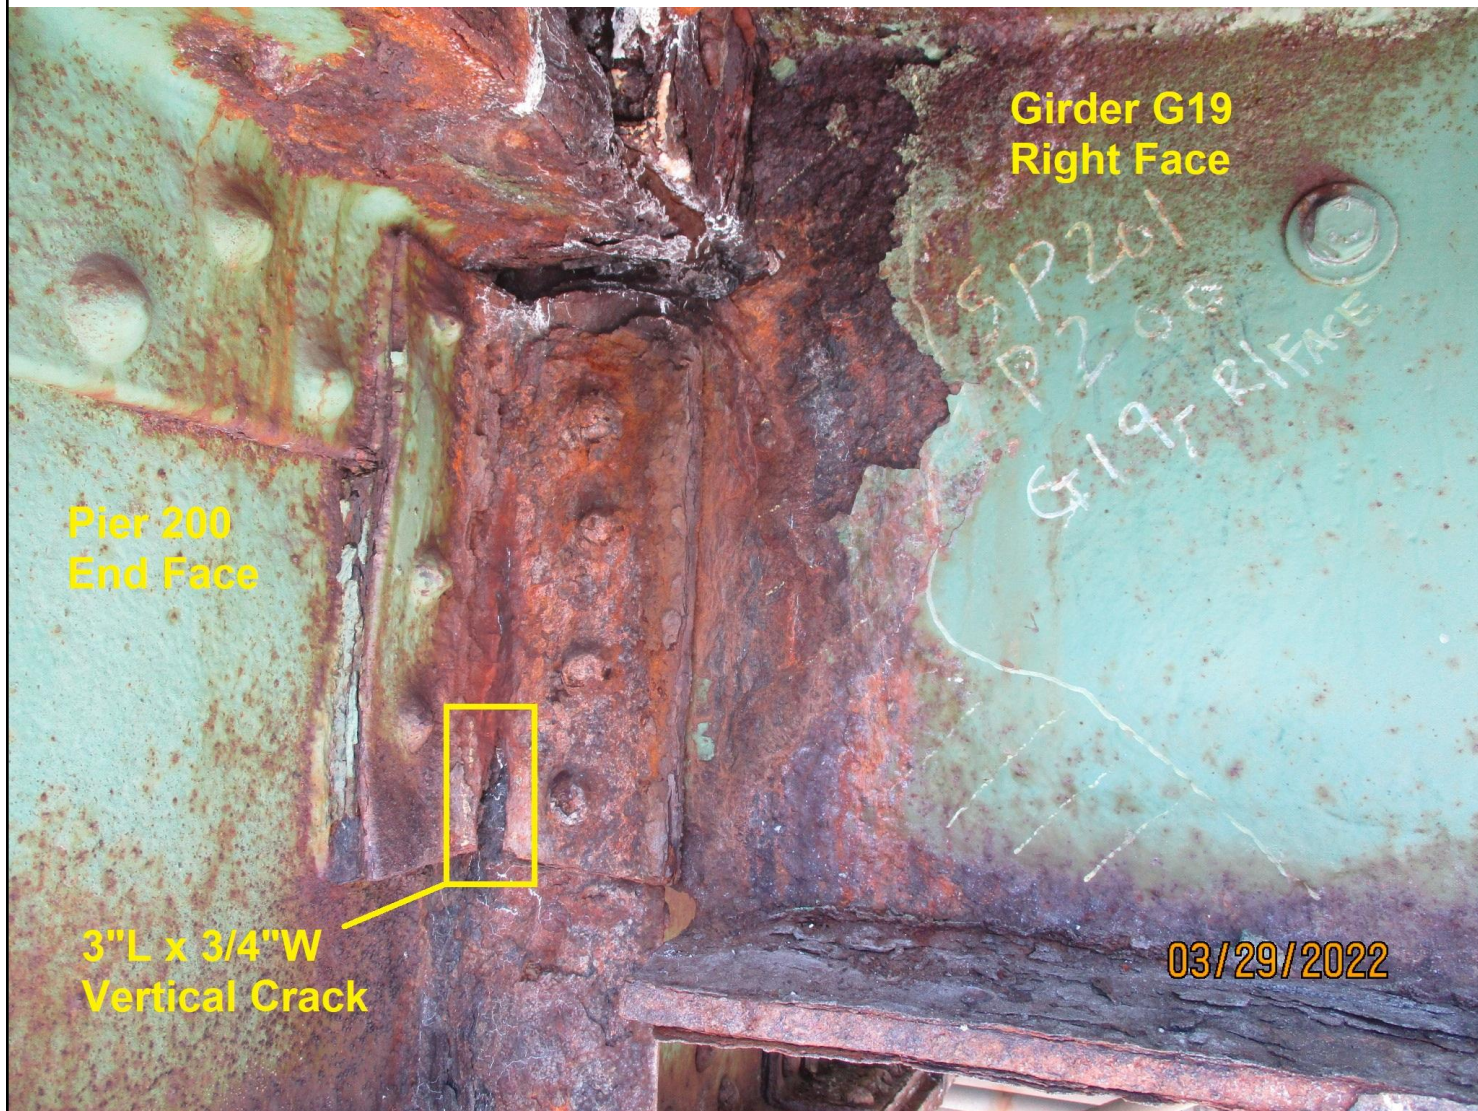
Photo Number: 2

Attachment Description: Span 201 Girder G19 at Pier 200. General view of the flagged location showing severe corrosion and cracking in the right connection angle of the girder to the pier cap. Looking Left.

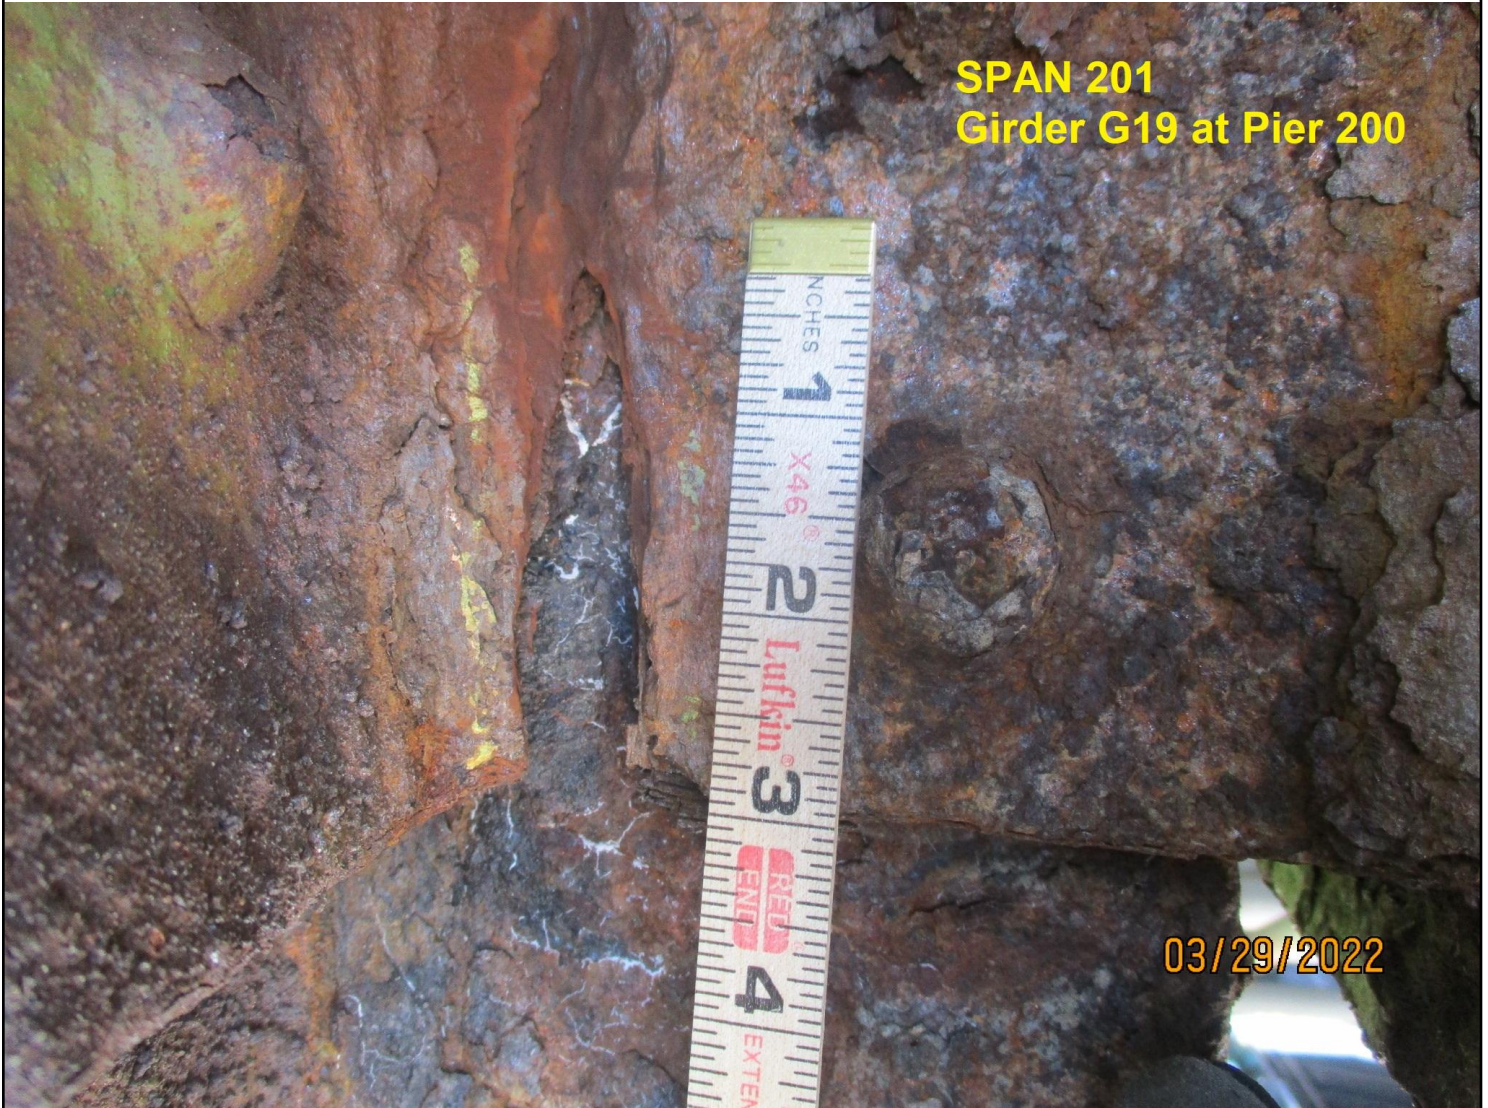
Photo Number: 3

Attachment Description: Span 201 Girder G19 at Pier 200. Close-up view of the flagged location showing severe corrosion and cracking in the right connection angle of the girder to the pier cap. Looking Left.

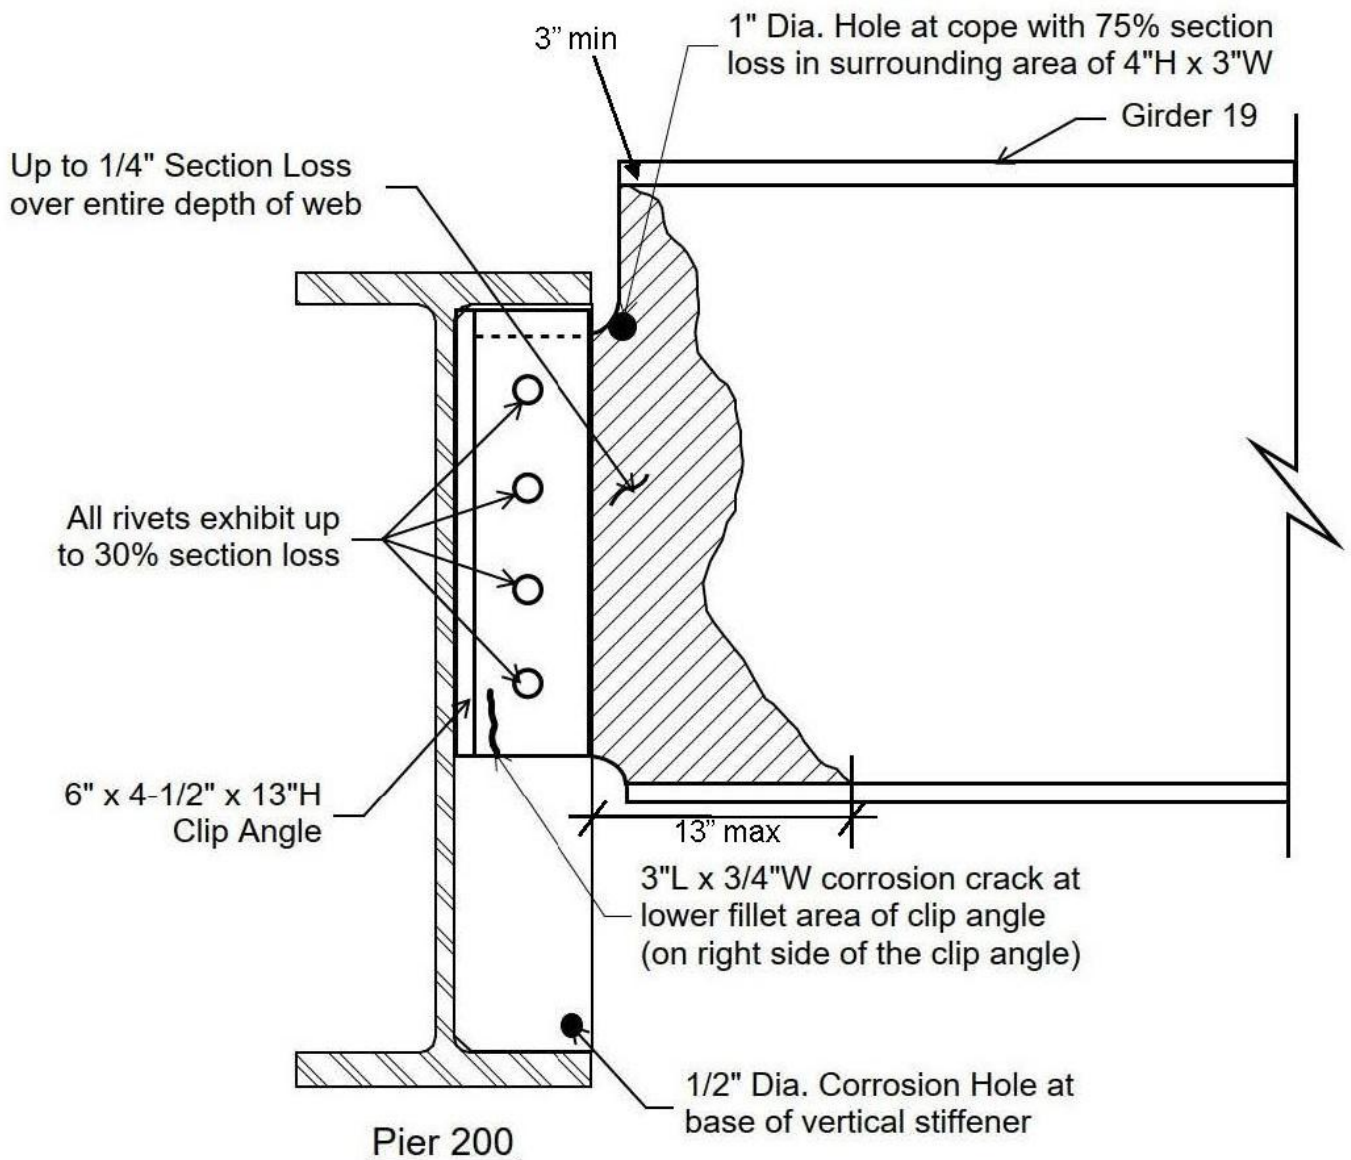
Photo Number: 4

**SPAN 201, GIRDER G19 BEAM END AT PIER 200****(LOOKING LEFT)****N.T.S**

Attachment Description: SN 201 G19 at Pier 200 Sketch

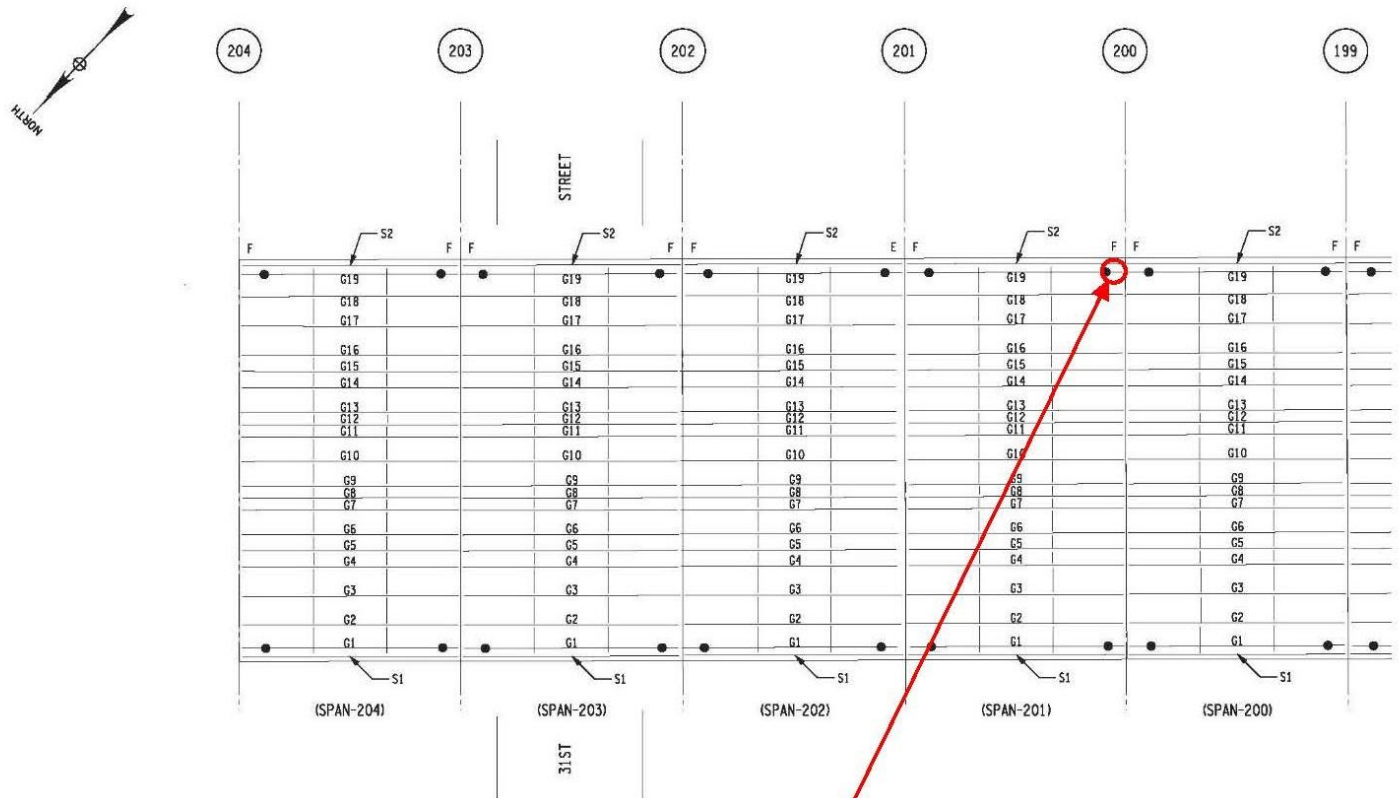
Photo Number: 5

**YELLOW FLAG
LOCATION
No. NB2228W018**

Attachment Description: SN 201 G19 at Pier 200 Framing Plan
